A CULTURAL RESOURCE MANAGEMENT PLAN

DZATA HERITAGE RESERVE

E.O.M. HANISCH
Department of Anthropology
University of Venda

April 2005

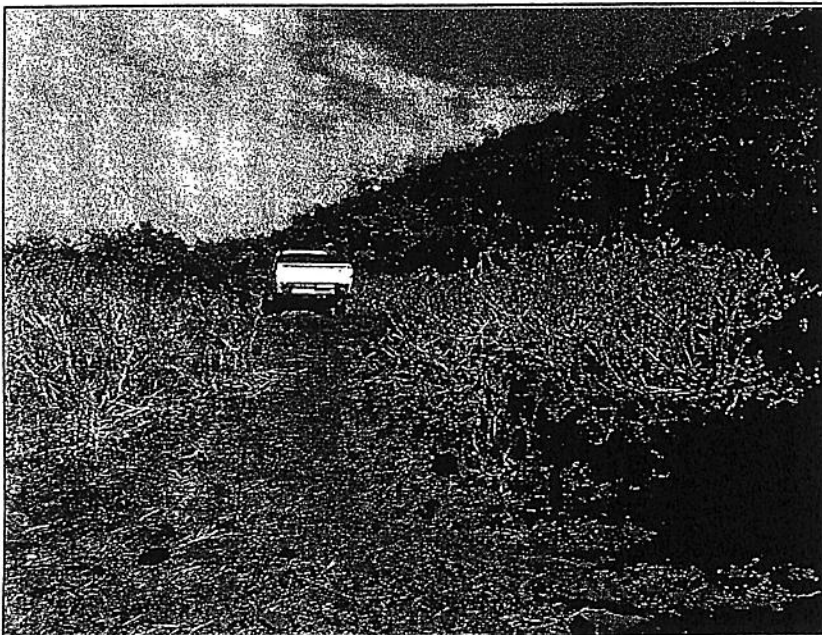
Figure 5 The cattle kraal of a Late Iron Age site on the slopes of the Soutpansberg Mountains. A road has been graded through it to allow access to the Gadabi River.

At the end of the first hairpin bend of the road leading up the mountain, a smaller road has been graded eastwards towards the Gadabi River Gorge. This road passes through a Late Iron Age site, with a cattle kraal, some midden remains and small terraces containing several rock slabs

with dolly holes. No diagnostic pottery was found to be able to date the site more or less. (See figures 5 and 6.)

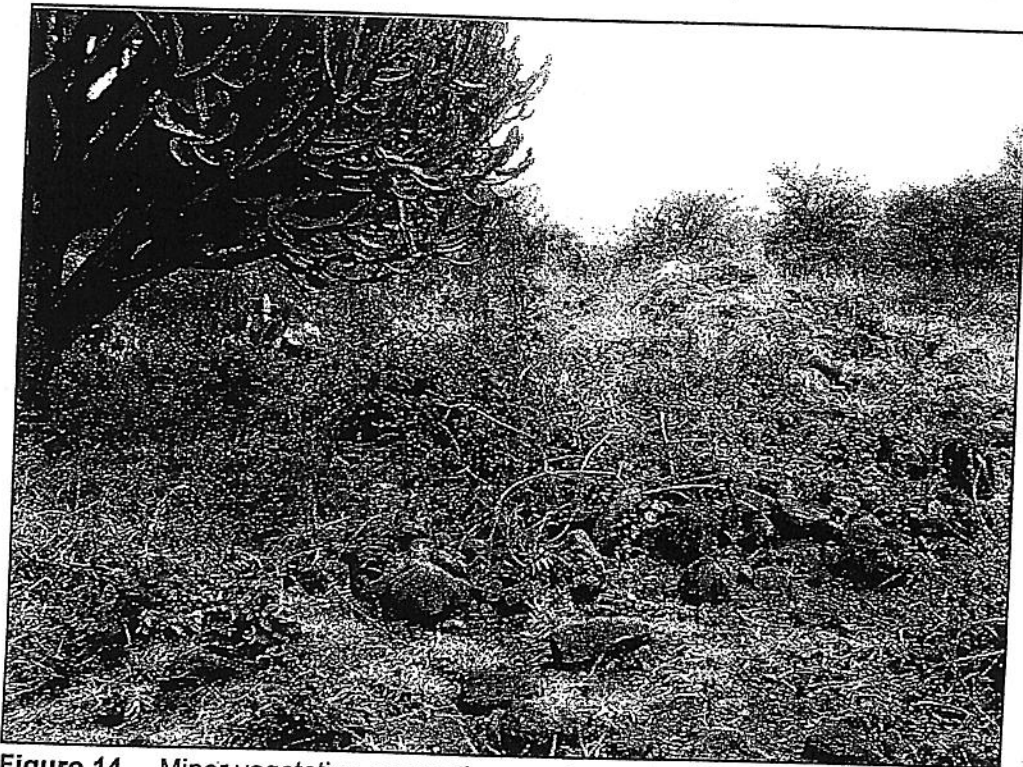
Figure 14 Minor vegetation covers these walls, partially hiding them from view. All such vegetation needs to be permanently cleared.

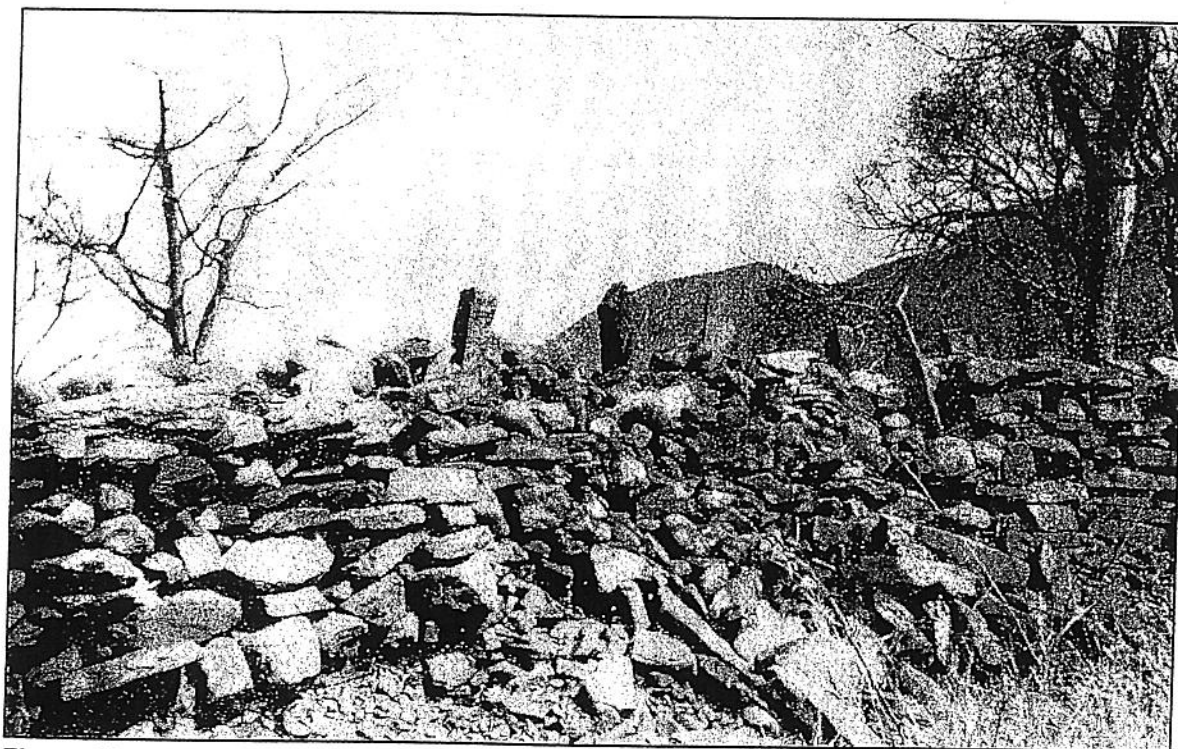
Figure 33 The original interior of the reconstructed wall in the above figure, showing the monoliths in position. According to a younger brother of the late P.R. Mphephu, three stones were placed on either side of a seat that was built into the wall. (Pers. comm. 1973)

The neat stone walls in the royal area (*musanda*) are mostly not original as they stand, but were dismantled and rebuilt somewhere between 1974 and 1978, but most likely closer to 1978. The foundations where the walls originally stood can still be seen sticking out in places from under the rebuilt walls.

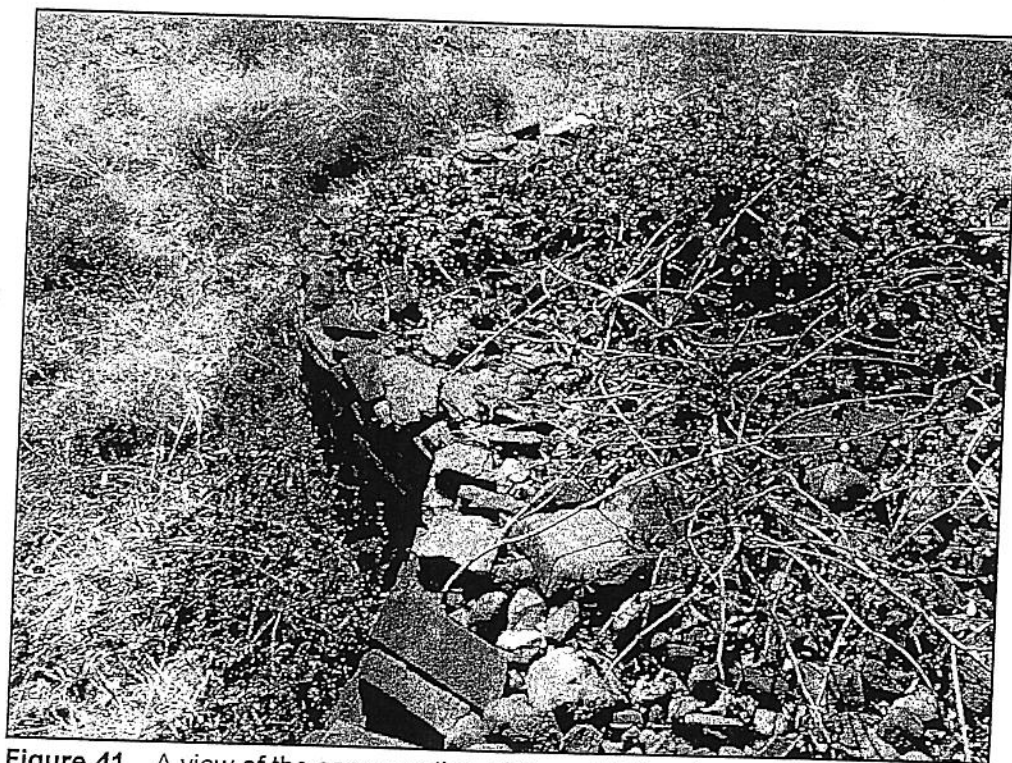
Figure 41 A view of the same section of the wall taken from above. The junction and artificial rounding can be clearly seen. The reconstruction would follow the outline of the original foundation. A herbicide would also need to be applied to eradicate any vegetation growing in the walls. See figure for information about reconstruction.

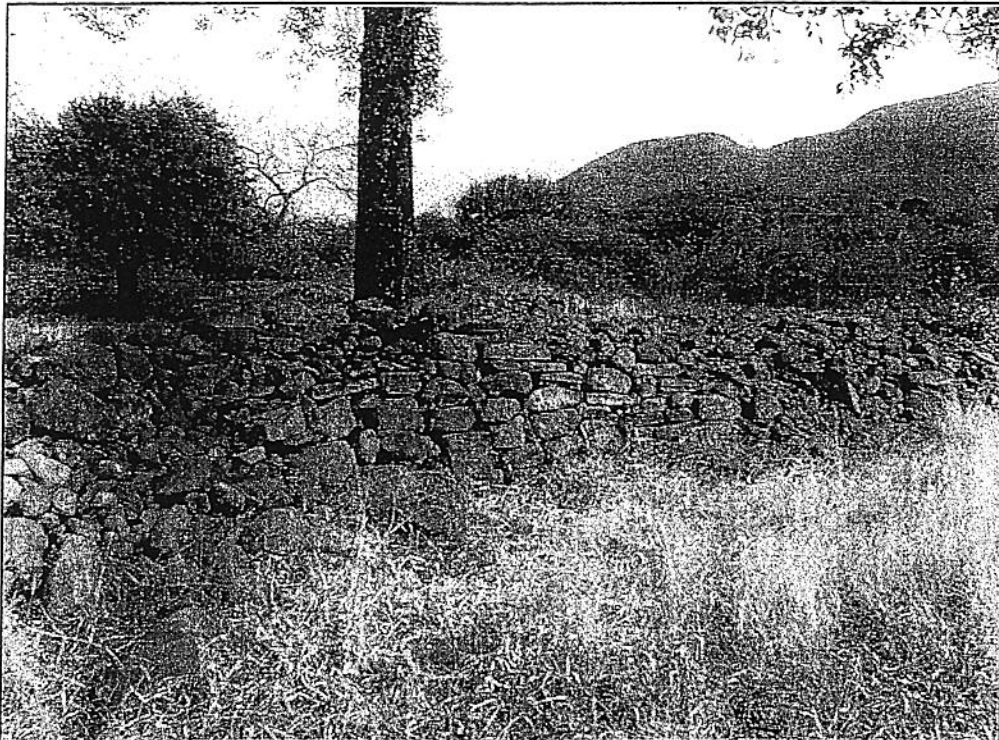
Figure 44 This wall is situated at the back of the *musanda*, and is thought to be some of the earliest walling at Dzata 2. It shows rough coursing and is made from different stone to that of the main walls. This should also be reconstructed according to the guidelines given elsewhere.

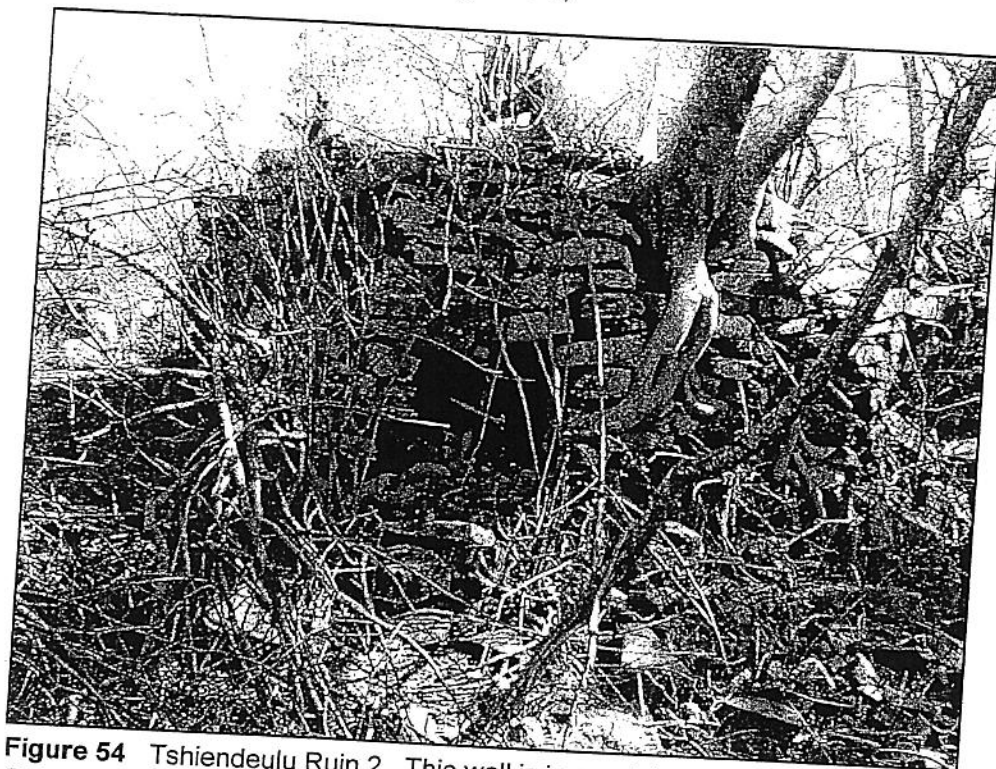
Figure 54 Tshiendeulu Ruin 2 This wall is in great danger of collapsing. Stones have fallen out and the top is no longer adequately supported. This structure forms part of a terrace, on which a house stood, as indicated by the remains of burnt daga structure found on top of the terrace. The trees must be cut down immediately. The wall will have to be dismantled, and rebuilt on a solid foundation.

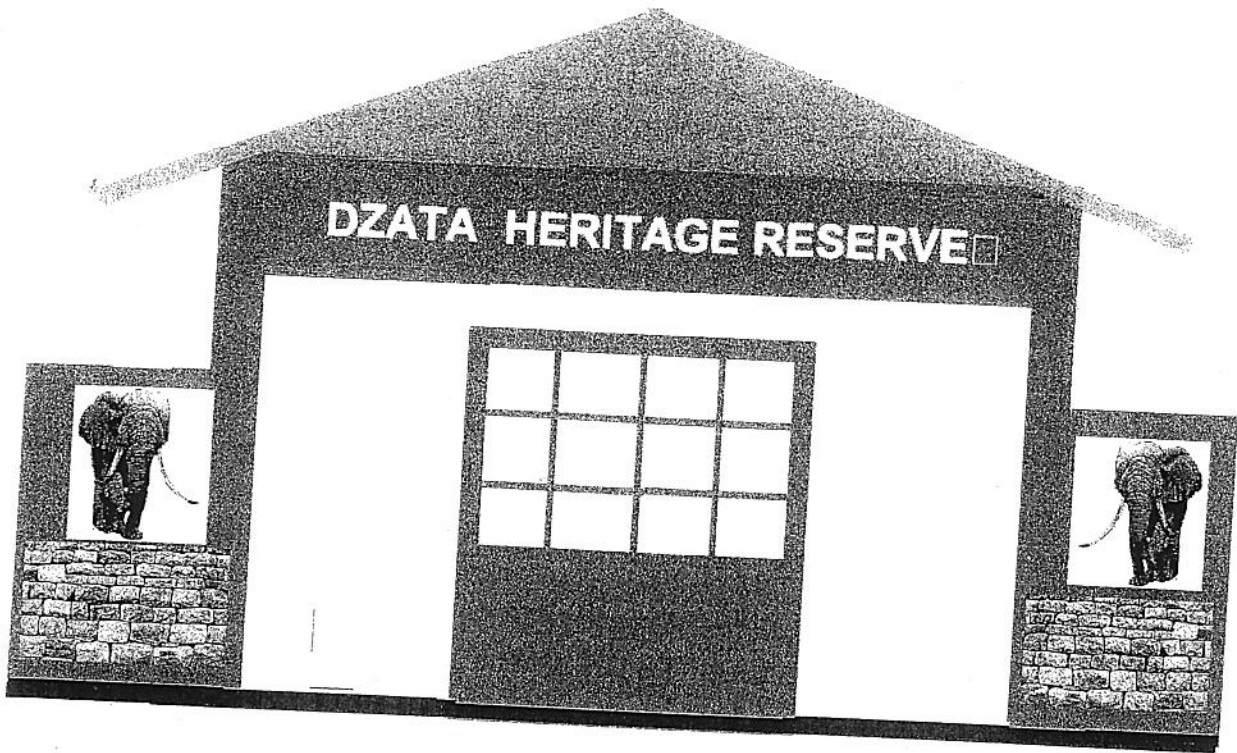
Figure 63 A suggested front view (not to scale) of the main entrance gate to the reserve, showing examples of symbolism built into the stone walls. Other examples can be chosen. The idea would be to show visitors that they are coming to a special place.

All symbols should be carved from stone, even if animals are included.

The entrance would be erected immediately beyond the point where the road to Dzata crosses the furrow. Suggested formats for the entrance can be seen in figures 62 and 63,
