SCHOEMANSDAL HERITAGE MANAGEMENT PLAN

March 2005

SCHOEMANSDAL ARCHAEOLOGICAL SITE MANAGEMENT PLAN

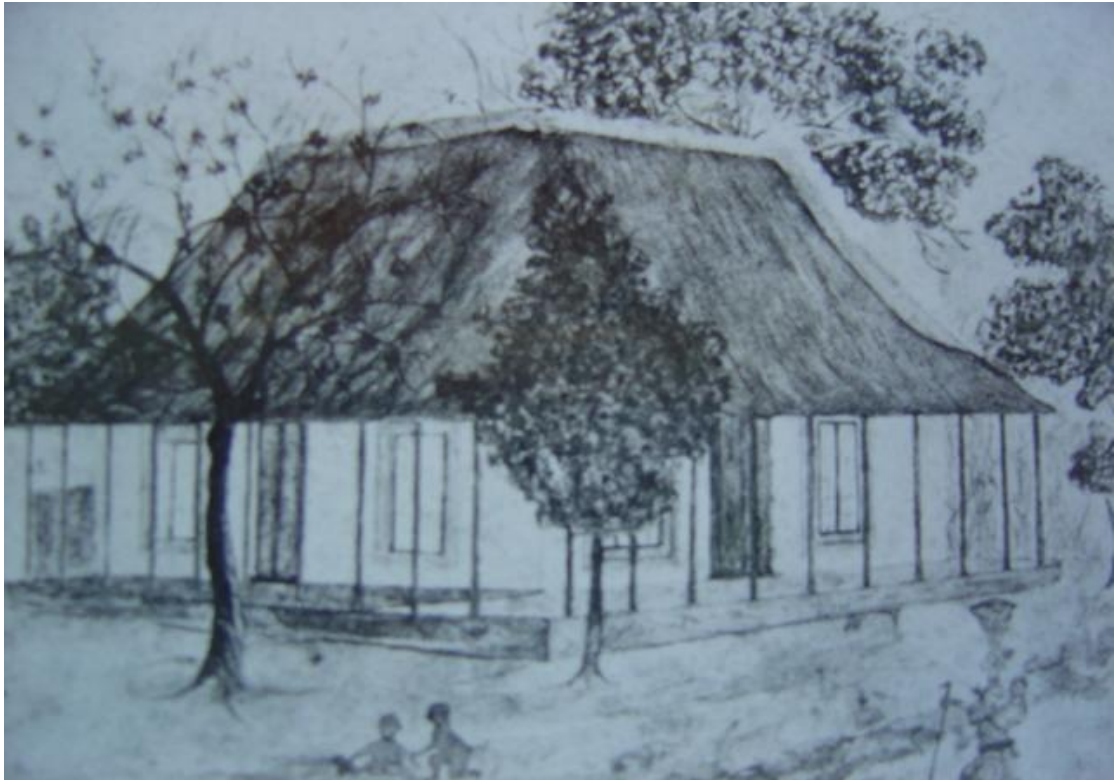
According to the Portuguese traveller, Deocleciano Das Neves, who visited Schoemansdal in 1855, the settlement never consisted of more than seventy houses. Archaeological excavations suggested however, that this number might have been greater. The market place, parsonage, church and redoubt were situated in the centre of the town. The construction of the second redoubt was started even before attempts were made to develop a new town. It was built of raw and burnt clay bricks, with cannons on two bastions and loopholes in the walls. Though never used in a war situation, the redoubt provided protection against possible attacks since 1866. The Dutch Reformed church was the first of its kind built in the Soutpansberg area. The building also served as a school for several years. The house originally built for Commandant-General Stephanus Schoeman later became the parsonage of the Reverend Nicolaas Jacobus van Warmelo. The house was of superior quality compared to other houses of the time (see photograph 1).

No.1 The house of reverent Van Warmelo

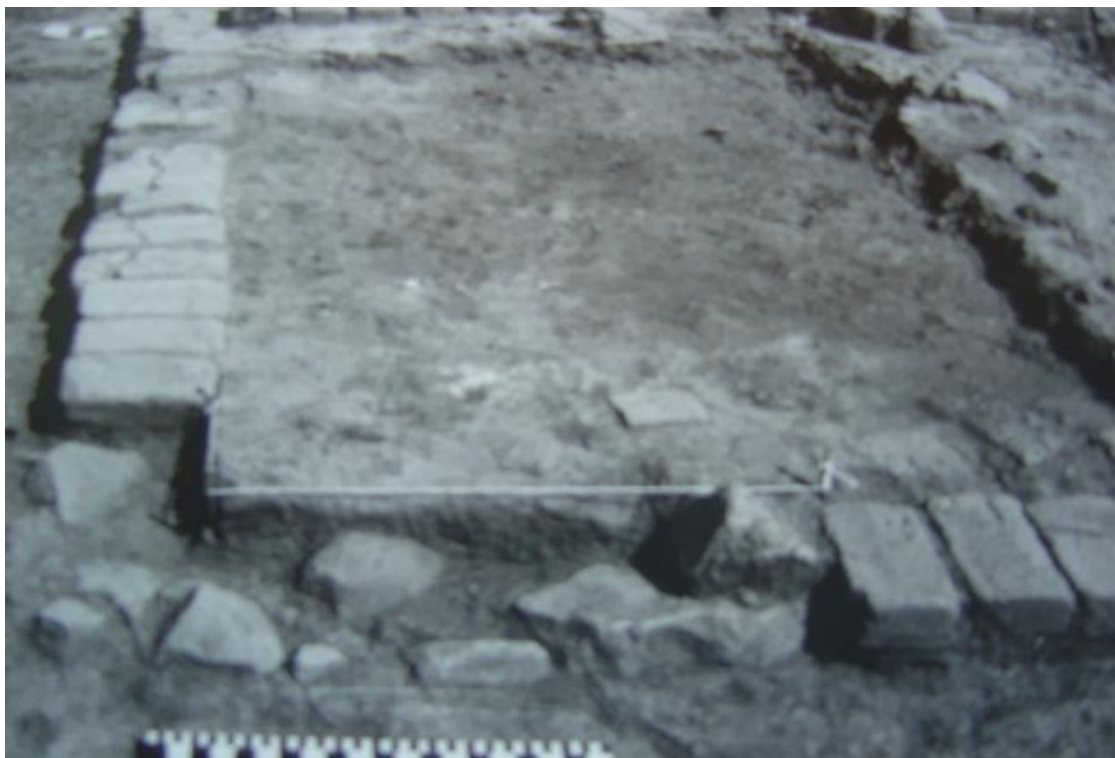
Archaeological research on the site has taken place from 1985. The research has to a large extent focused on the mapping of the site and the excavations of the most important structures. These included the following:

- Church
- Hendrik Potgieters workshop
- “Onderste skans” – Redoubt
- Structure E6/R1 – Lower redoubt/Lower fortification
- Structure R2 – Possible small two roomed house
- Parsonage
- New Redoubt
- Water furrow System
- Ammunition store

No. 2 Archaeological excavations of a structure

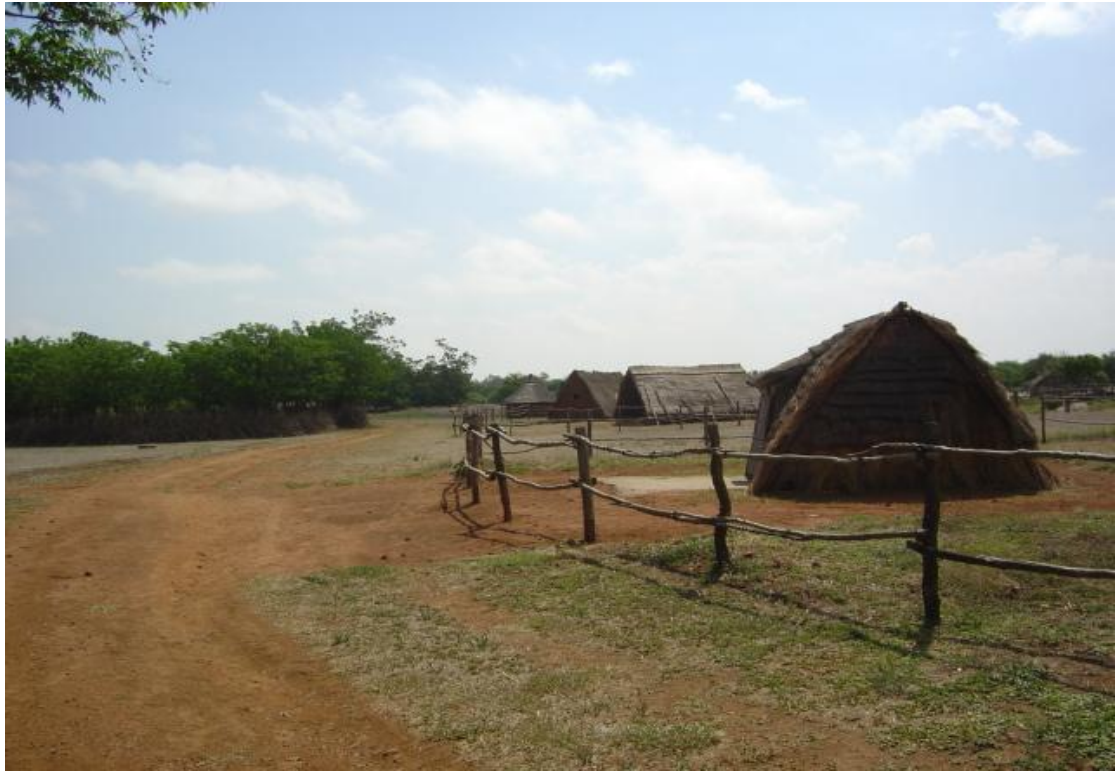
The archaeological site at Schoemansdal forms part of the Schoemansdal Museum. The Museum consists of a total area of 600 hectares. A security fence has been erected around the area. An entrance gate, which is not in operation at present controls access. Visitors report at the exhibition centre. The exhibition deals with the history of Schoemansdal and that of the Venda people. From here visitors are taken on a guided tour through a reconstructed pioneer settlement just south of the archaeological site (see photograph 3).

No. 3 Reconstructed structures in the first settlement

The visitors then move to the reconstructed early settlement with a security officer (guide). The buildings in this section of the Museum need regular maintenance, as they are all pole and mud structures with thatched roofs. Maintenance of this section is an ongoing task and should be presented as part of the visitor's experience. Plants and vegetable gardens, which one would expect in such an early settlement, together with chickens, ducks, sheep and goats, are lacking. At present the site looks deserted and dead. In the past there were a number of activities like the baking of bread, tanning and other activities, which unfortunately have been stopped due to a lack of funds and staff. These activities should be reinstated.

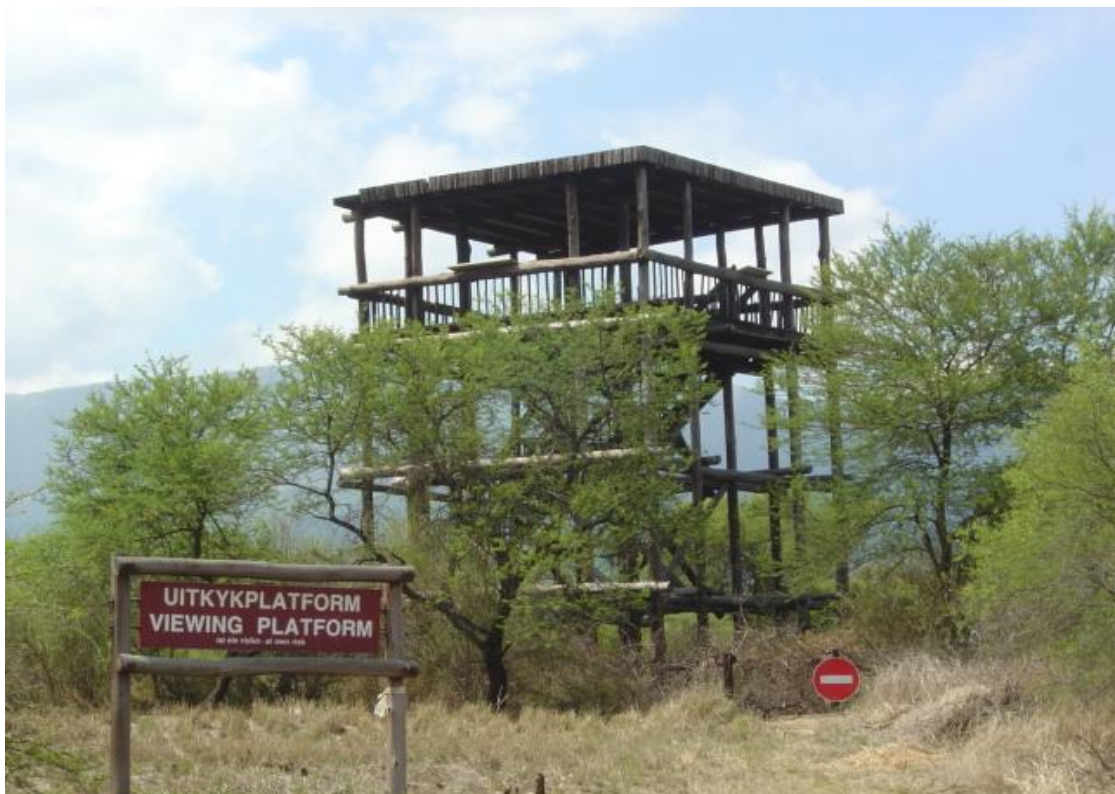
Visitors were also taken to a viewpoint overlooking the archaeological site. This viewpoint consisted of a pole structure and viewing platform some five metres above ground level. Unfortunately this platform has deteriorated to such an extent that it had to be closed. Information panels explain the layout of the site to the visitor. The information panels have faded over the years and are illegible. The site itself is so overgrown by trees, shrubs and grass that nothing is visible except vegetation. The tall grass also prohibits tours (see photographs 4-6).

No. 4 Viewing platform

The visitors then move on to the view platform, which at present is falling apart and needs urgent repair. Though this platform gives the visitor an elevated view of what is supposed to be the archaeological site, the only thing visible is bushveld - trees, shrubs and grass. By taking out most trees and shrubs and cutting short the grass in the original streets, the visitors will get a good view of the layout of the town. The present information panels on the viewing platform should be placed so that visitors can identify important structures and their own location on site. An additional panel should depict what the town would have looked like in the past.

The viewing platform should be properly repaired and made safe for visitors. Once this has been done the wood should be treated annually to prevent it from decaying. Minor repairs might be necessary from time to time. The present bad state of the structure is largely due to the lack of maintenance.

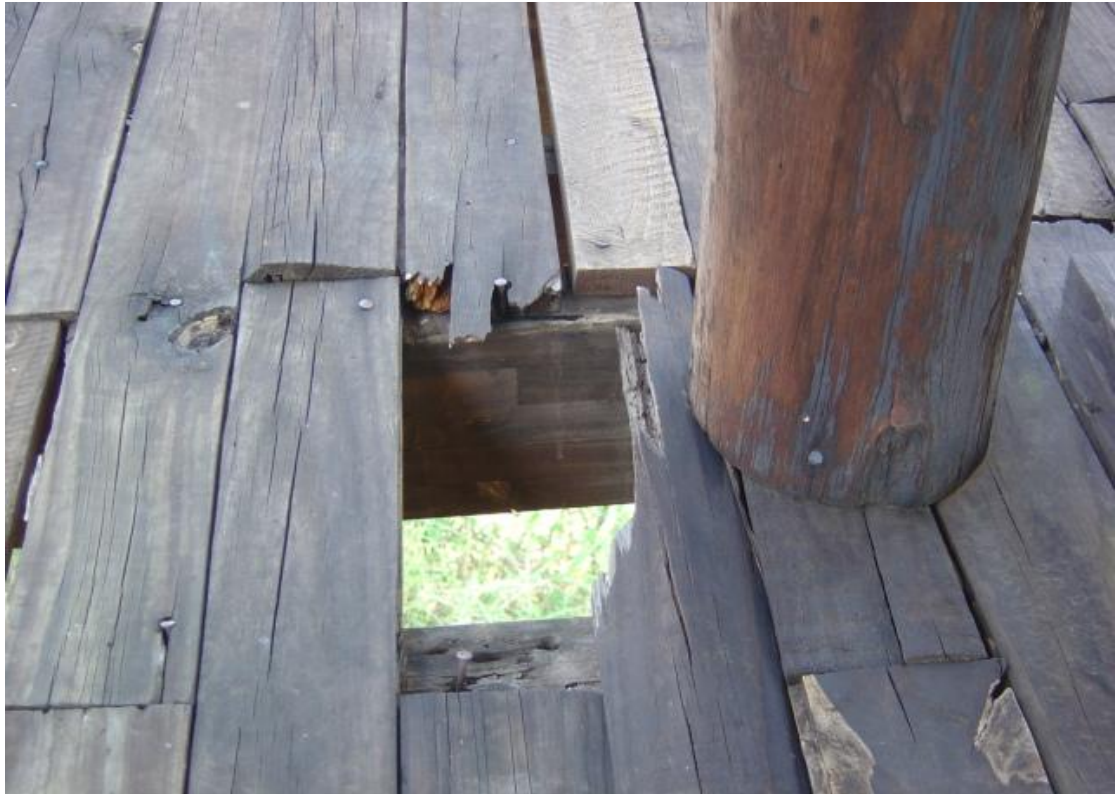
No. 5 Rotten floorboards of the viewing platform

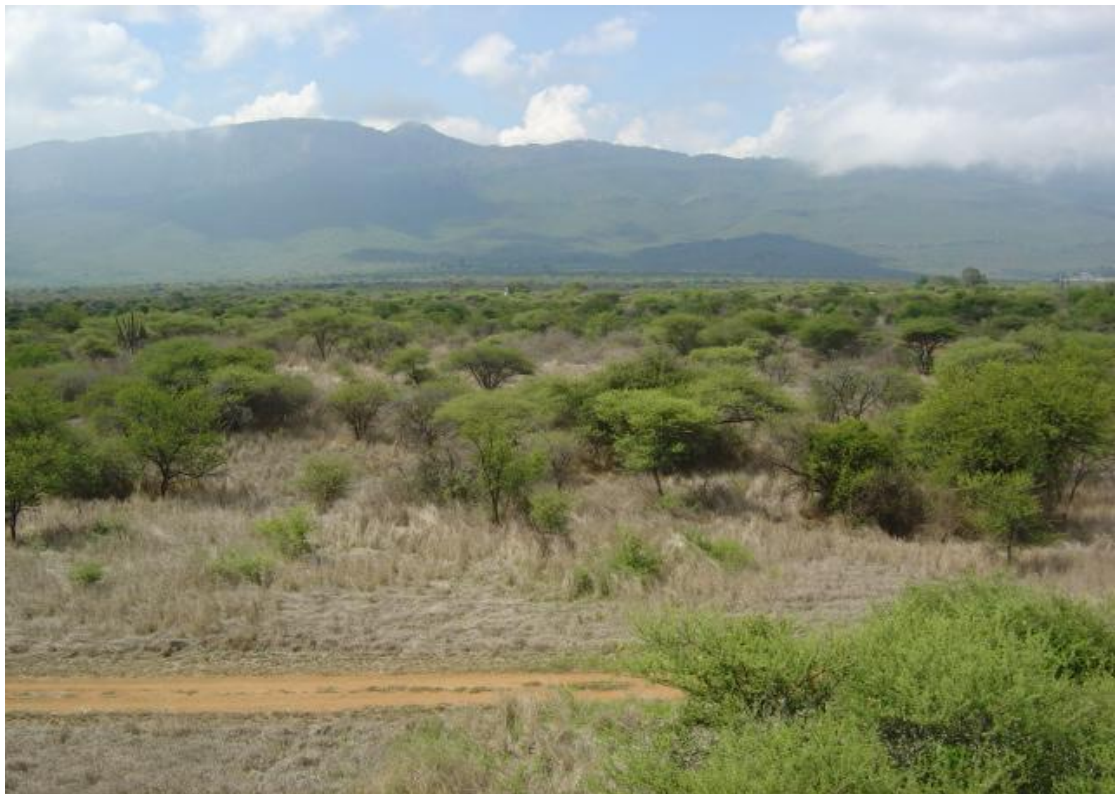
No. 6 View over the archaeological site as seen from the viewing platform with the Soutpansberg in the background

- All trees and shrubs on the archaeological site with the exception of a number of shade trees be cut and the trunks treated with a herbicide (weed killer) to prevent them growing again. Digging out the trunks could harm the archaeological deposit.
- A number of large shade trees must be selected for the visitors to rest. These should be selected from trees, which grow in or near the original streets and not on old foundations.
- The grass on all the original streets as well as on the outskirts of the site should be cut on a regular basis to keep it short. This would divide the site into street blocks, and could act as firebreaks. At the same time it would give the visitors demarcated walkways and a good impression of the town's layout.

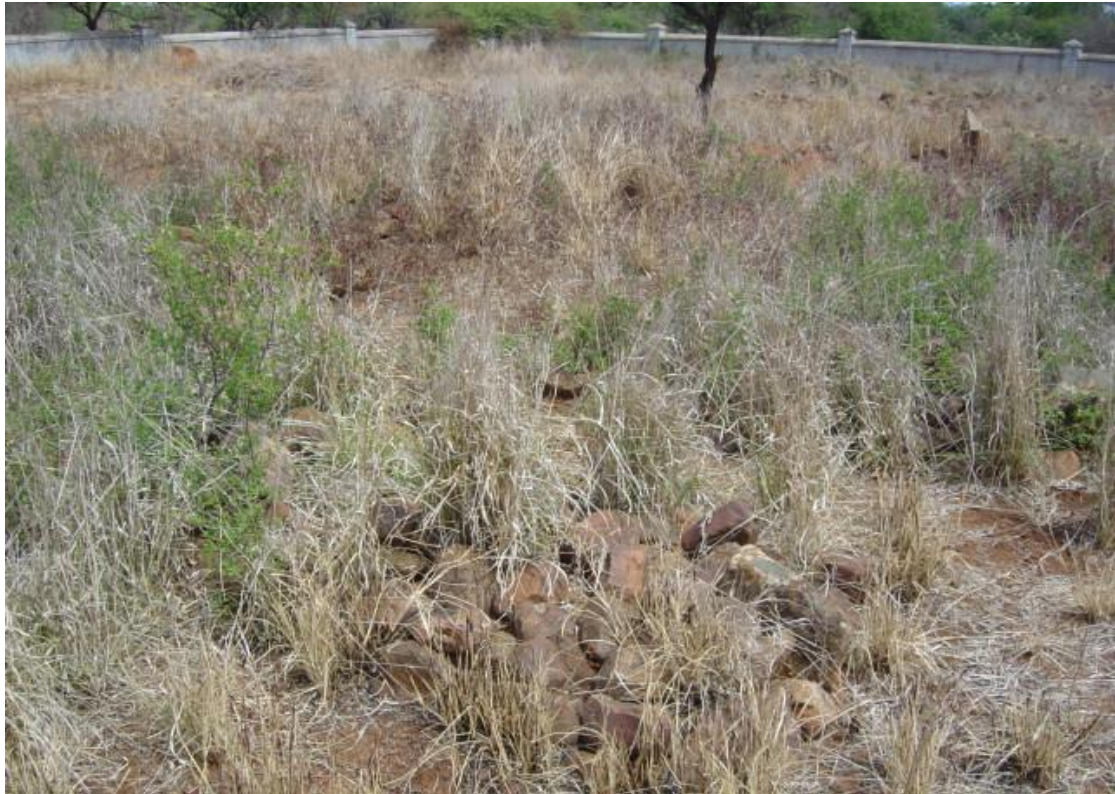
Visitors can also go to the graveyard. This area is also totally overgrown with grass, weeds and thorn trees so that the cemetery is inaccessible.

Once a year the site is cleaned by the Schoemansdal *Geloftefees komitee* who is responsible for the commemoration of the Day of the Covenant, now called Day of Reconciliation on 16 December each year (see photograph 7).

No.7 Graves in the graveyard are hardly visible because of uncontrolled vegetation

A visit to the site will end at the graveyard. This whole area should be cleared of all vegetation and be treated on a regular basis with a herbicide. A granite plaque should also be placed here with particulars on the graveyard.

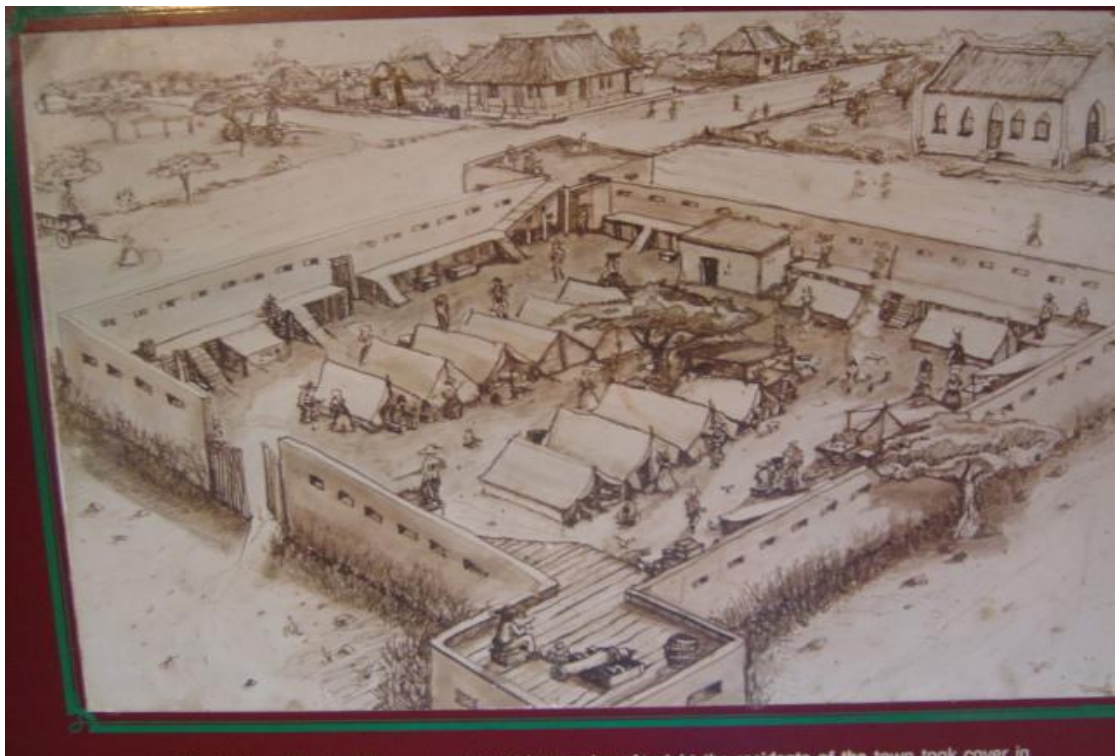
From the parking area visitors go to the exhibition area. The building and exhibitions are in good condition. The floor needs repair. The information on the history of Schoemansdal and its surroundings is sufficient and well presented (see photograph 8).

No. 8 Detail of one of the panels in the exhibition area showing the redoubt in the foreground with the church behind it

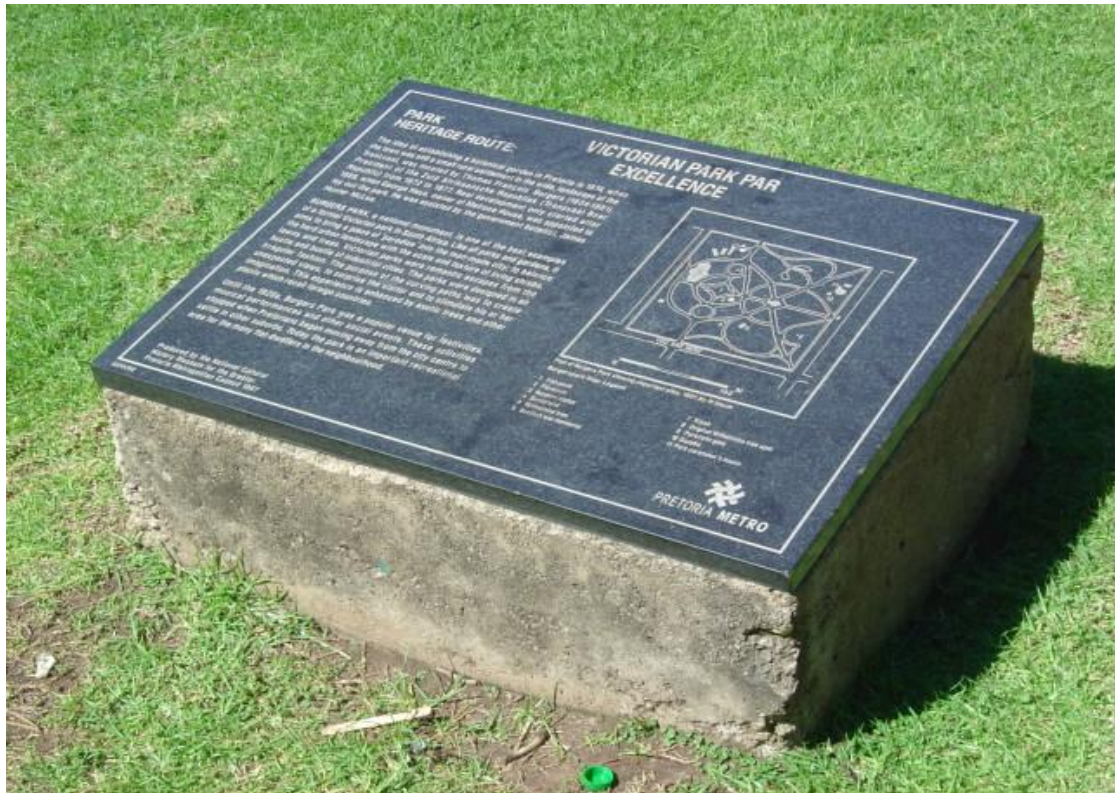
much cheaper. These granite panels could be fixed flat on the ground so that they have little visual impact on the site (for an example of a granite panel, see photograph 9).

No. 9 Example of a granite information panel

From here the visitor should be taken on a guided tour through the town. Street names should be marked on the ground on cement or concrete slabs so that visitors know where they are. In a similar way the owners of the various stands should also be named (see Site plan 2 with names of individual owners). In the case of important structures like the church, the fortification and other buildings of which drawings exist, these should be sandblasted or etched onto granite slabs. Granite lasts a very long time and is not popular with thieves, as is the case with bronze plaques. It is also
